6.0L Diesel Talk LIVE

6.0L Recalibration for Cold Injector Spool Valve Sticking

October 25, 2006

- **Today - 6.0L Recalibration for Cold Injector Spool Valve Sticking**
TSB 06-22-3
- Turbocharger Information
 - Presentations will be available on Power Stroke Central
 - Links to streaming video will be available on Power Stroke Central

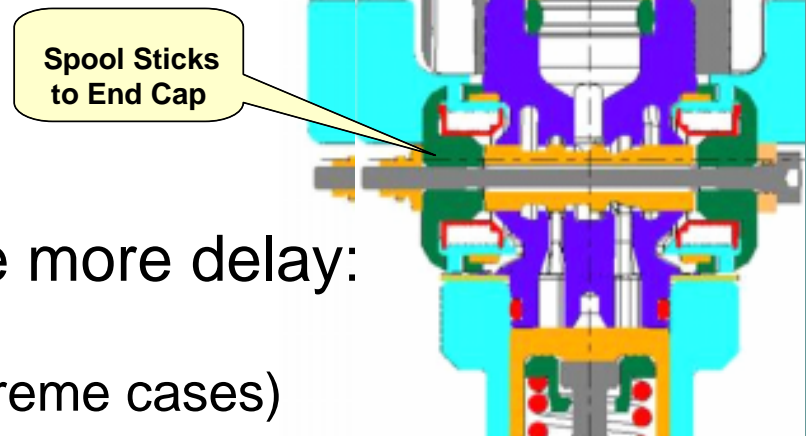
- Stiction is caused by excess oil in the closed side end cap/spool interface area increasing the hydraulic latching of the spool valve
 - Stiction increases as oil viscosity increases
 - Temperature decreases
 - Oil viscosity changes
 - Oil ages
 - Oil additives
 - Oil type, weight

The colder and thicker the oil, the more delay:

- Rough idle
- Lacks power/no pedal response (extreme cases)
- White smoke

- A new calibration has been developed and extensively tested in lab and field over the past 6 months.
 - Removes the oil in the spool-endcap interface inside the injector by cycling the spool valves for 30 seconds.
 - At start up, the coils are left on longer to heat & thin the oil. The injector performs as if EOT is warm.
- This is a permanent fix, more effective long-term than injector replacement (since any injector can develop stiction)

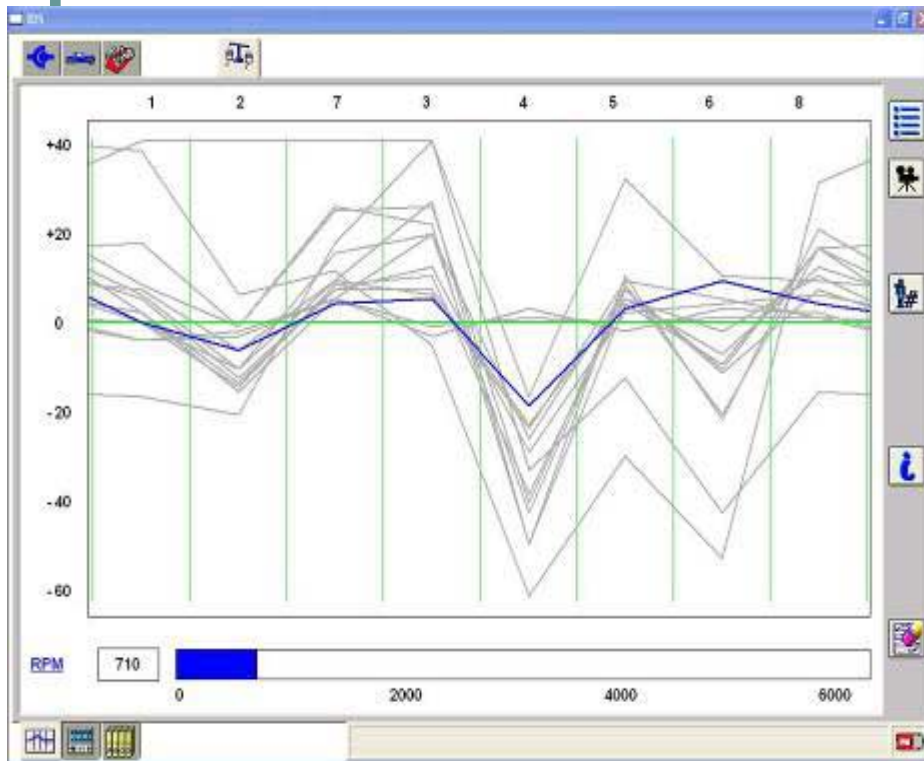
Production software cold start

171K Field test vehicle, Sheboygan, WI

- Same start temp, power balance snapshot of first 60 seconds after start
- No issues since reflash, vehicles continue to perform as temp drops

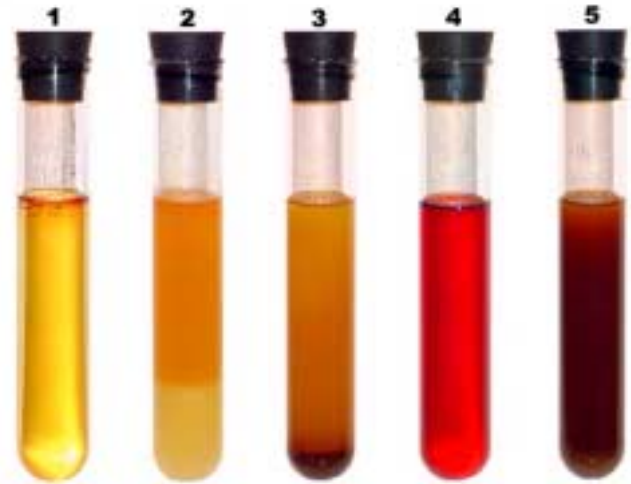
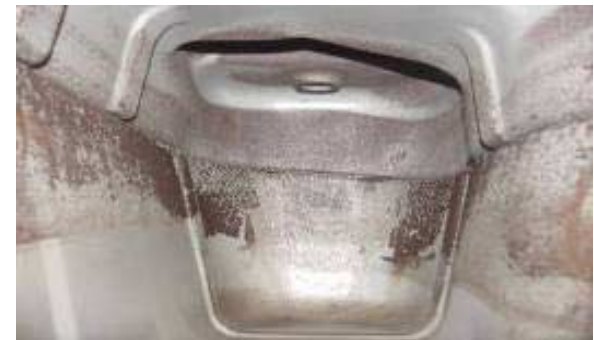
- Poor Fuel Quality
 - 1: Good clean fuel
 - 2: Fuel contaminated with water
 - 3: Fuel contaminated with dirt
 - 4: Off-highway fuel
 - 5: Contaminated
- Additives
- Driving Conditions
 - Road salts
 - Dusty roads
- Delamination of Steel Fuel Tanks
 - Steel tanks are on F-Series Chassis Cabs and E-Series
 - **SSM 18945**
